# Manhole Inspection Summary

Manhole # S27CC\_036MH

Insp Date: **5/13/09 11:15 AM**

**Location** Address: **1427 PENNSYLVANIA AVE**

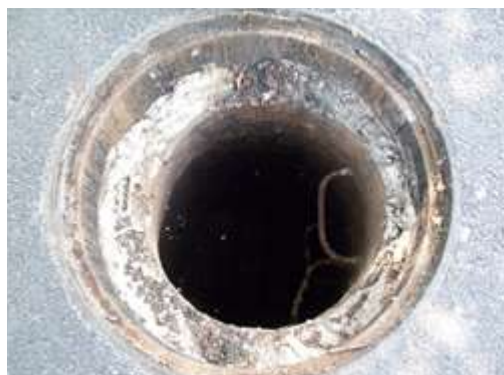
Defect 1

Comments **broken cover**

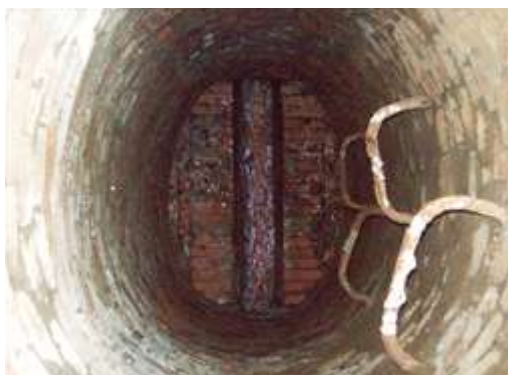
Defect 2

**Steps** Count: **6** Missing: **0** ☒ **Corroded**

STEPS CORRODED

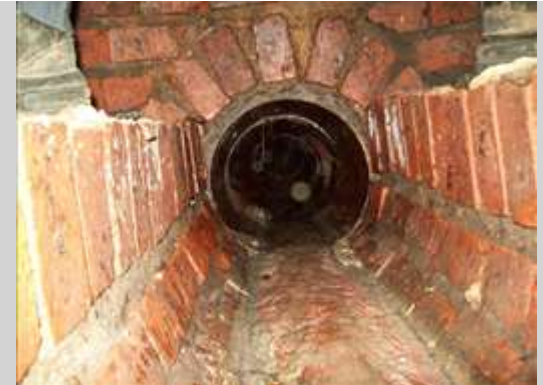
12 O'Clock Outflow

8 in. Circular Gravity Sewer  
Pipe Out @ 12 O'Clock

Pipe Height: (in.) Direct  
Pipe Material: **PVC** ☐ Pipe Lined  
Invert Depth: **10.50** (ft.) Flow Characteristics: **Slow**  
Deposits: ☒ None ☐ Mud ☐ Sludge ☐ Debris ☐ Grease  
Silt Depth: (in.) Deposits Extent:  
Infiltration: **None** Pipe Seal Cond: **Sound**

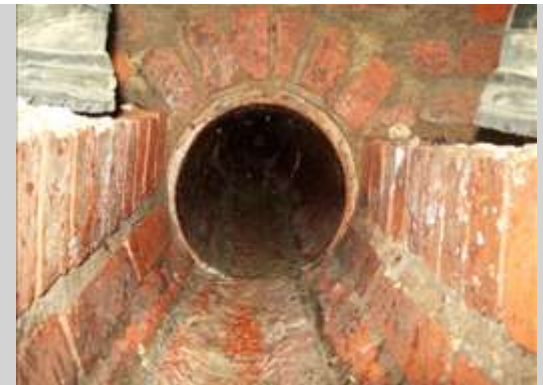
6 O'Clock Inflow

8 in. Circular Gravity Sewer  
Pipe In @ 6 O'Clock

Pipe Height: (in.) Direct  
Pipe Material: **PVC** ☐ Pipe Lined  
Invert Depth: **10.58** (ft.) Flow Characteristics: **Slow**  
Deposits: ☒ None ☐ Mud ☐ Sludge ☐ Debris ☐ Grease  
Silt Depth: (in.) Deposits Extent:  
Infiltration: **None** Pipe Seal Cond: **Sound**
